# **BUILDING INSPECTION REPORT FOR** **JOHN & MARY HOMEBUYER**

Allied  
Building  
Inspections

Home Inspection  
Report

**1234 MAIN STREET.**

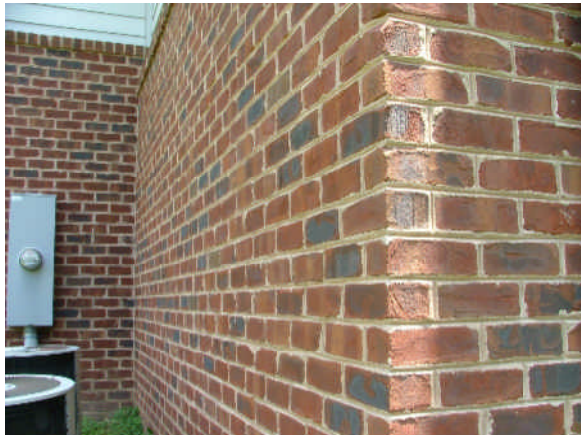
The cladding/siding components are performing as intended without signs of significant damage or defects, The photo shows typical condition of the exterior cladding at the time of inspection.

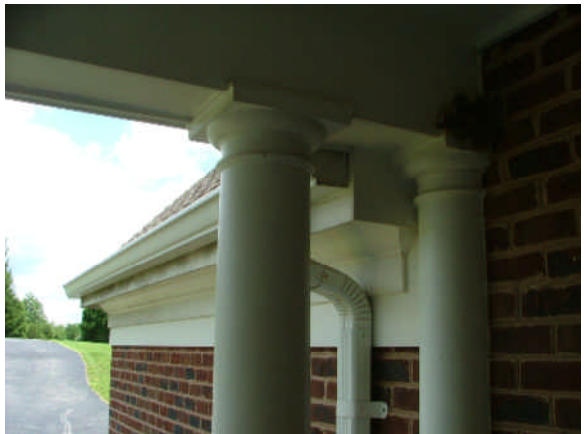
The wood/metal trim components are performing as intended without signs of significant damage or defects, The photo shows typical condition of the exterior trim at the time of inspection.

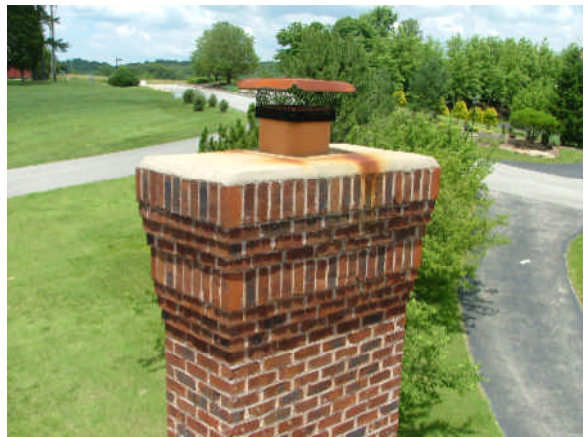
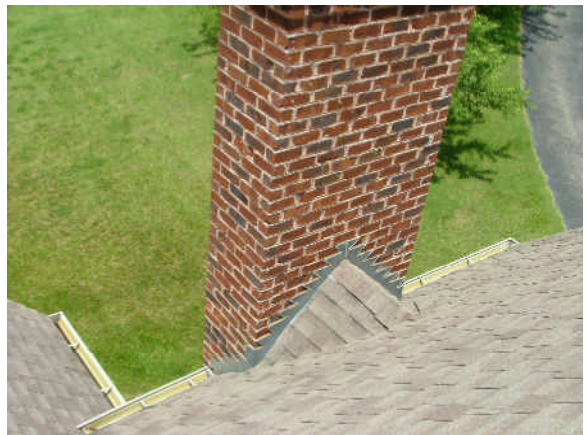
The components of the chimney chase are performing as intended without signs of significant damage or defects, Photo shows chimney chase performing as intended with proper flashing.

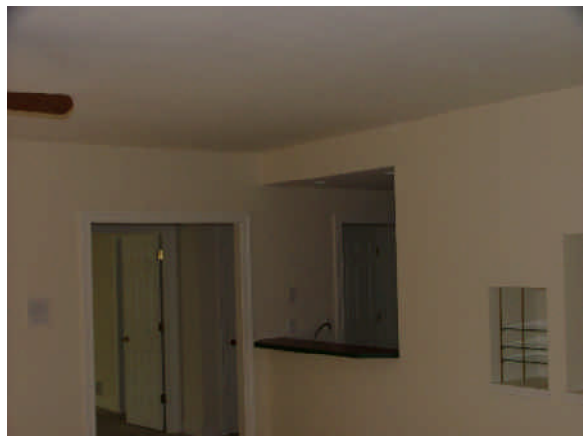
Basement is only partially accessible- Viewing was restricted by wall coverings, ceilings, and floor coverings, see photo.

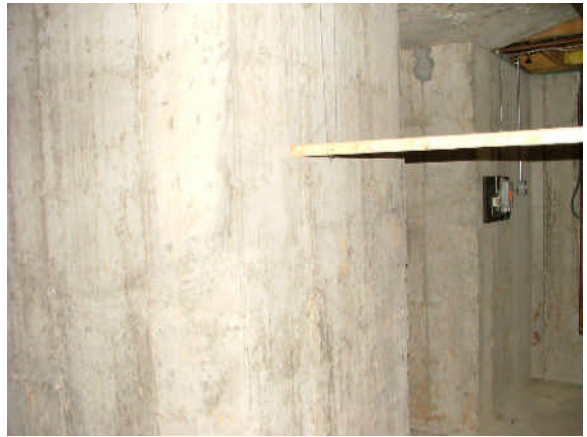
Minor settlement cracks noted, not significant at this time, The components of the foundation walls are performing as intended without signs of significant damage or defects at the time of inspection, Photo shows typical condition of concrete foundation wall.

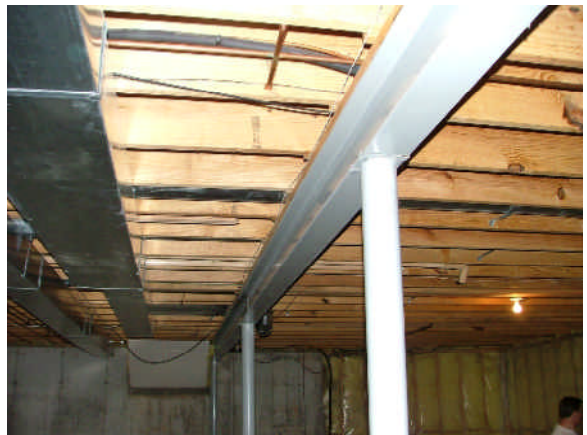
Visible portions of the beams are performing as intended without signs of significant damage or defects at the time of the inspection, Photo shows steel beams and posts, and floor joists performing as intended.

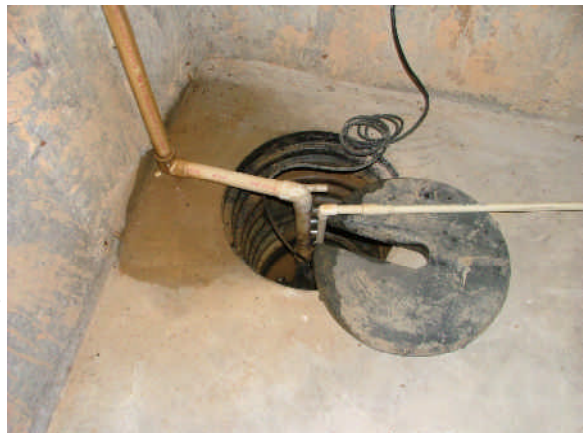
No evidence of water or moisture penetration visible at the time of inspection, The sump pump was inspected and operated and performed as intended at the time of inspection. These type motors typically have a 6-8 year service life. Repair is usually not feasible and replacement is most always recommended after failure. See photo.

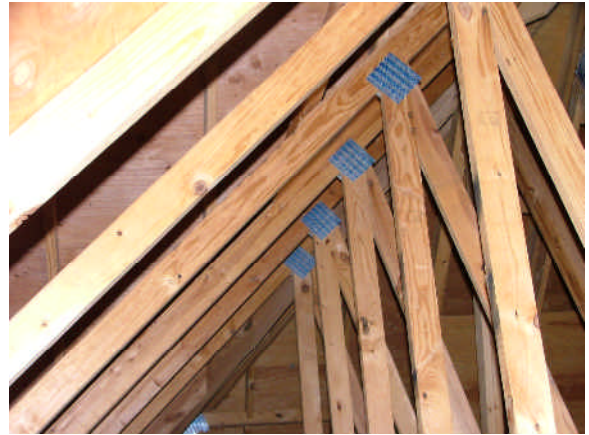
Roof framing consists of standard wood trusses that are performing as intended without any signs of damage or distortions. Photo shows roof structure performing as intended, which was typical from end to end.

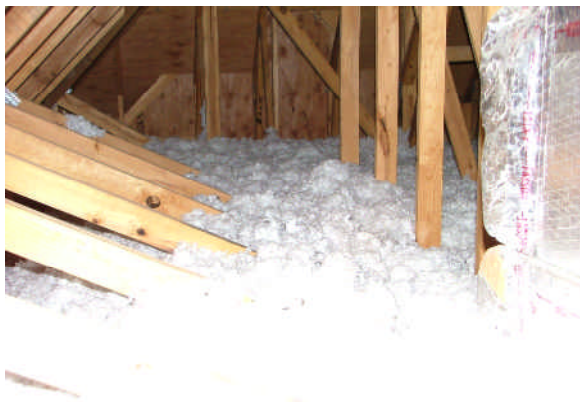
Mineral wool, Ventilation is present and provided at, Gable ends, Soffit vents, Roof vents/ turbine vents on the slopes, The attic is well ventilated. This will extend the service life on the roofing if all other conditions are performing as intended as well. Photo shows insulation and roof structure performing as intended.

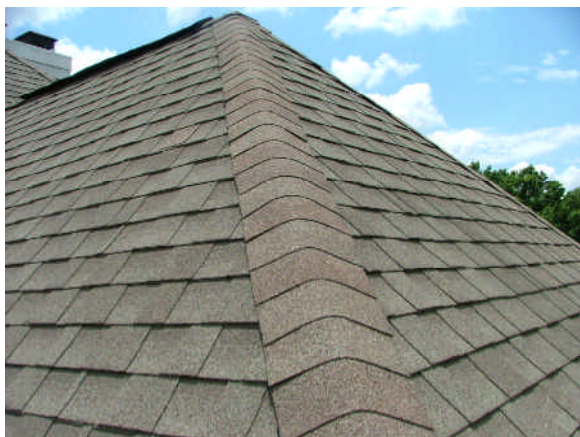
The roofing appeared to be a professional installation and was performing as intended without any evidence of damaged, loose, or missing shingles. All roof penetrations were properly flashed with metal. No evidence of leaks or water penetration was observed when inspecting from the attic as well. it is likely that this roofing will reach its average service life if normal weather conditions prevails. Photo shows asphalt shingle roofing aligned properly with no defects, which was typical for both sides of the slope.

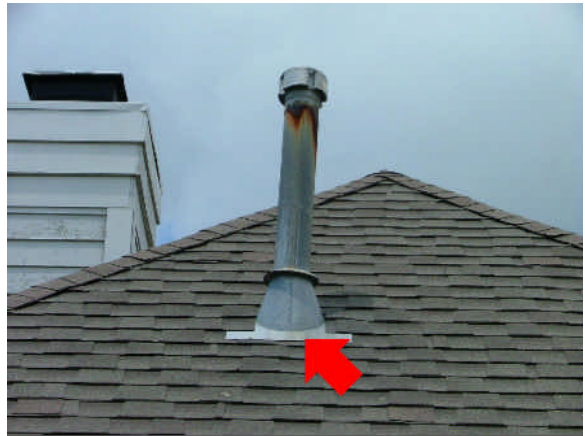
Metal, The exposed and visible flashings at the roof penetrations were properly installed with approved materials and were performing as intended without signs of damage or deterioration. Photo shows flashings performing as intended.

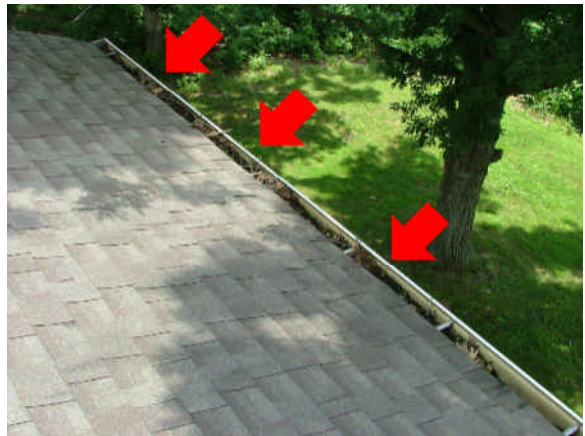
Full, Debris in gutter, Gutter is sloped improperly and holding water- Damage/Defects viewed, Photo shows clogged gutters in need of repair and improvement.

No major defects or deficiencies noted at the time of inspection. No repair or replacement is needed or recommended at this time. Multiple layers observed, this is allowed but anticipate a reduction of service life. All layers should be removed on the next roof installation. Most manufacturers do not warrant/guarantee shingles when installed over existing roofing, The roofing had typical wear and deterioration for its age. No evidence of leaks or water penetration. Deterioration included minor to moderate granule loss only. Roofing appears to be 30 year rated dementional shingles, Actual wear life appears to be 15-20 years of age, Tree debris, leaves, and branches left to rot on the roofing will accelerate deterioration. Clean and maintain to extend service life. The gutters were clogged and will hold water. Clean and maintain to prevent drip edge deterioration.

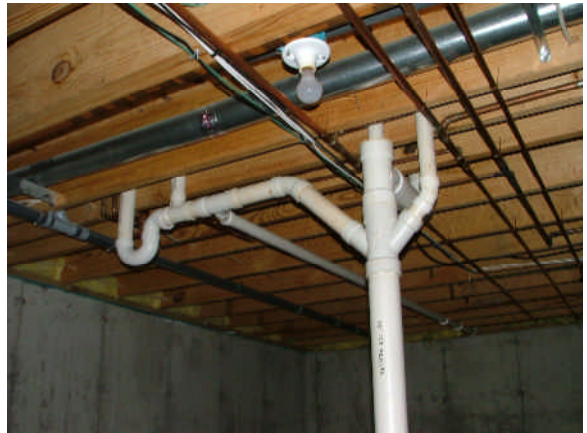
Visible portions of the waste lines were performing as intended without significant signs of damage or defects, or any type of leakage. Plumbing vents appear serviceable, Lines not fully visible, Photo shows main stack in basement performing during full load operational test without leakage.

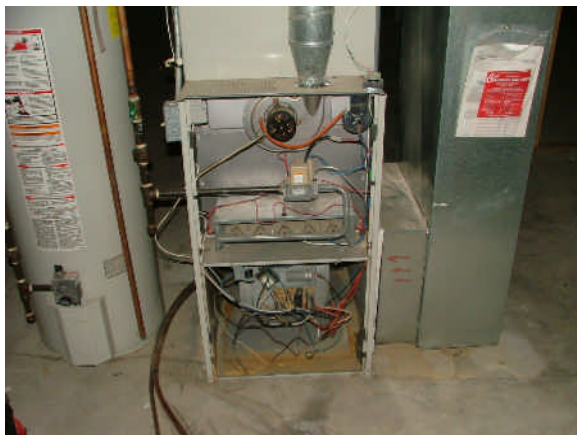
<b>PRIMARY UNIT:</b>	The unit was operational and performing as intended at the time of inspection. The photo shows the furnace with the panel covers off for inspection purposes only.
----------------------	--

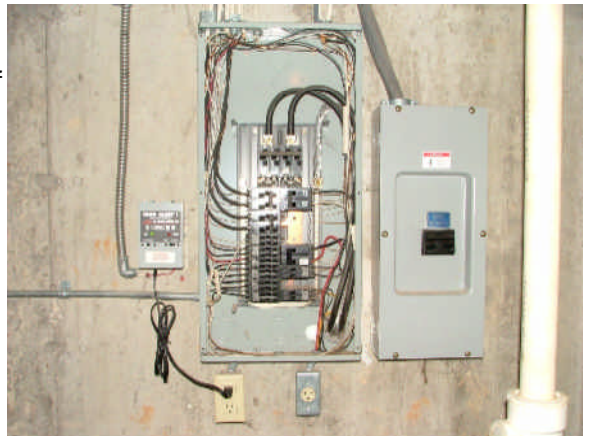
Basement, Photo shows main service panel performing as intended. The panel cover is off for inspection purposes only.

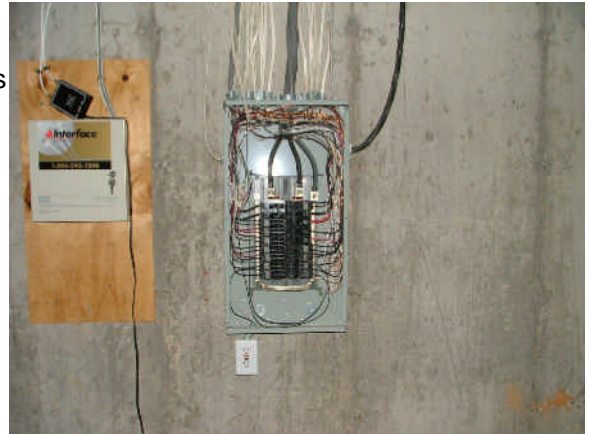
Circuit and wire sizing correct so far as visible, Grounding system is present, Photo shows general conditions of the sub panel at the time of inspection.

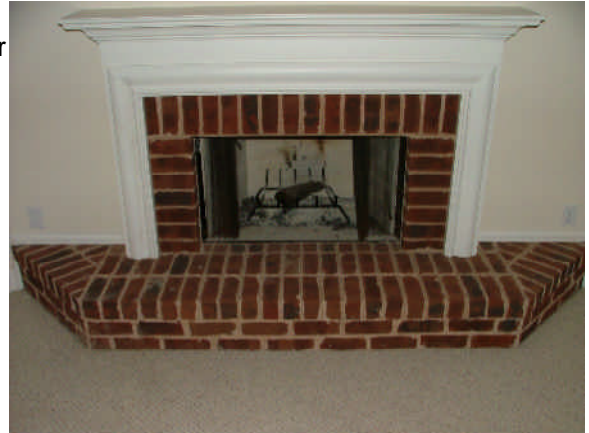
Location #1: Main living area, Mortar joints are intact, Damper is operational, Recommend cleaning before use, Fireplace components that were visible performed as intended without signs of significant damage or defects. See photo.

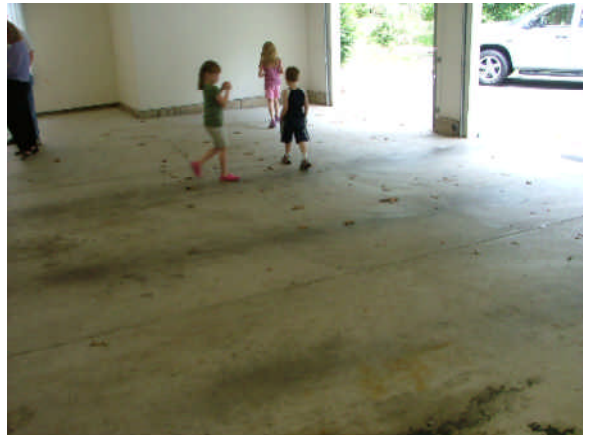
Typical cracks noted, The concrete garage floor was performing as intended without signs of significant damage or defects at the time of inspection. See photo.

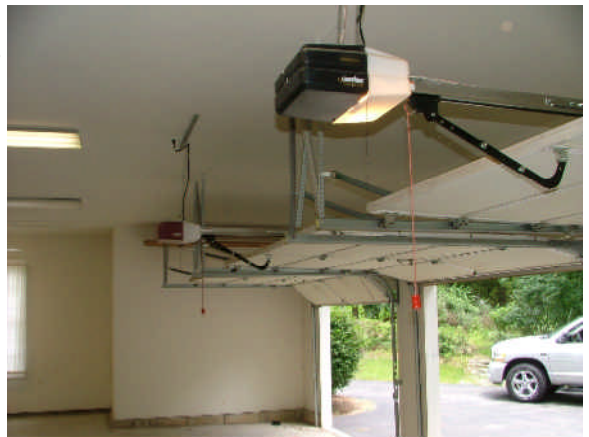
The garage door is metal, The garage door was performing as intended without signs of defects or damage at the time of inspection, Automatic door opener(s)- operational, Automatic reverse feature is, operational. Photo shows door openers in operation at the time of inspection.

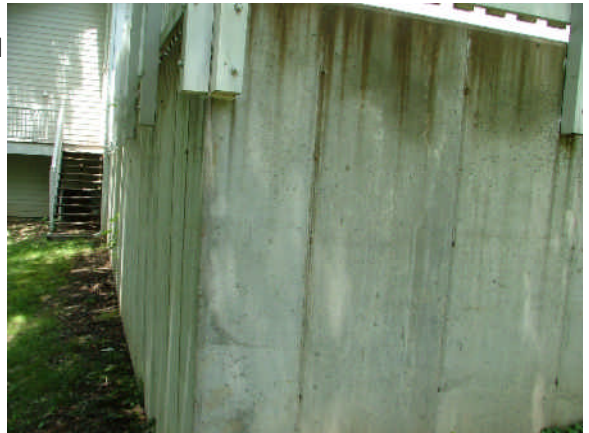
The retaining wall(s) on the property were properly installed and were performing as intended without signs of significant deterioration or damage, The photo shows the general conditions of the retaining wall at the time of inspection.

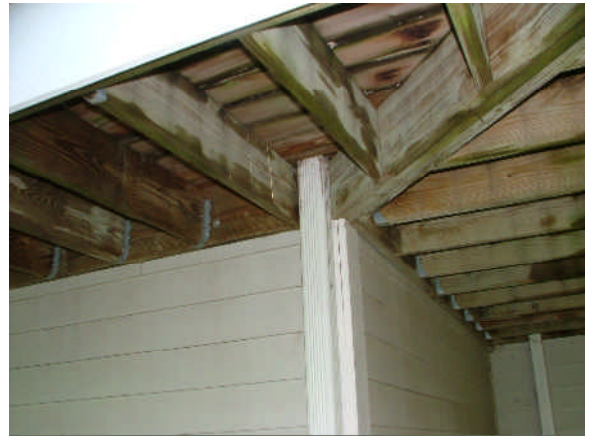
Deterioration noted to deck surface, Improper conditions viewed, Handrails are loose/improper/missing. Correction is recommended, The photo shows the deck structure from below not properly attached.

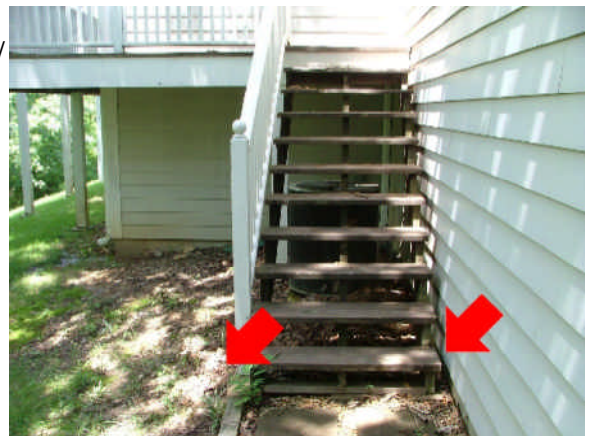
Settlement/rotation noted, Loose Step(s), Handrails loose/improper, not secured, see photo.
